# OPERATING EXPERIENCE SUMMARY

**Office of Environment, Safety and Health**

**Summary 2001-12  
December 17, 2001**

# Operating Experience Summary 2001-12

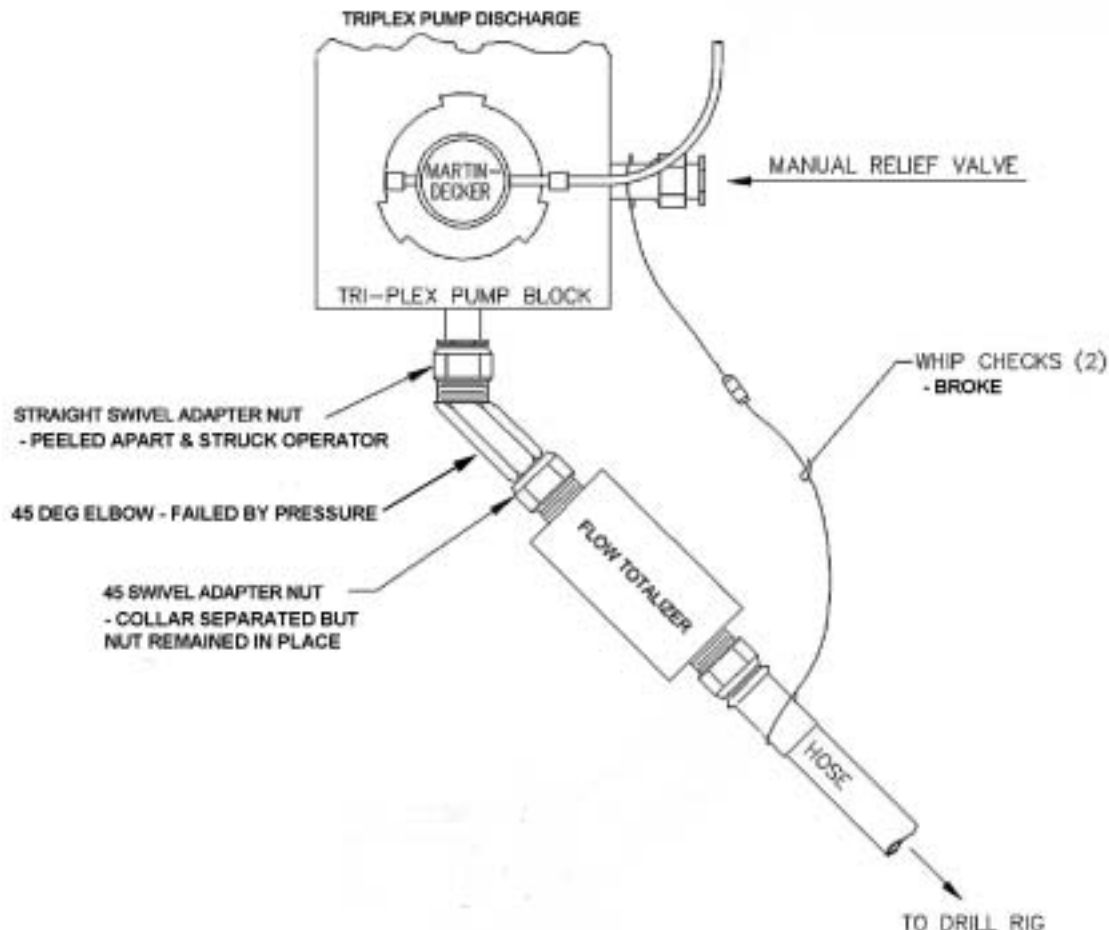
Figure 1. Diagram of fitting assembly

The investigation concluded that the direct cause of the accident was the use of a fitting not strong enough for the pressures seen in service. The 45-degree swivel elbow was rated for a maximum pressure of 3,000 pounds per square inch (psi), whereas normal pressure during grouting operations was 6,000 psi, and nozzle plugging could raise pressures above 10,000 psi. Nozzle plugging and leakage were recurrent problems during grouting operations. To repair leaks, the subcontractor had recently purchased and replaced hose and fittings, including the 45-degree swivel elbow. However, as evidenced by the failures, the subcontractor apparently did not understand the design and safety demands of his equipment, and installed parts inadequate for the pressure load experienced in service.

The investigation also concluded that the pressure shutdown features of the grouting system were ineffective and not well understood. An automatic pressure relief device downstream of the pump could have prevented over-pressurization caused by nozzle plugging.

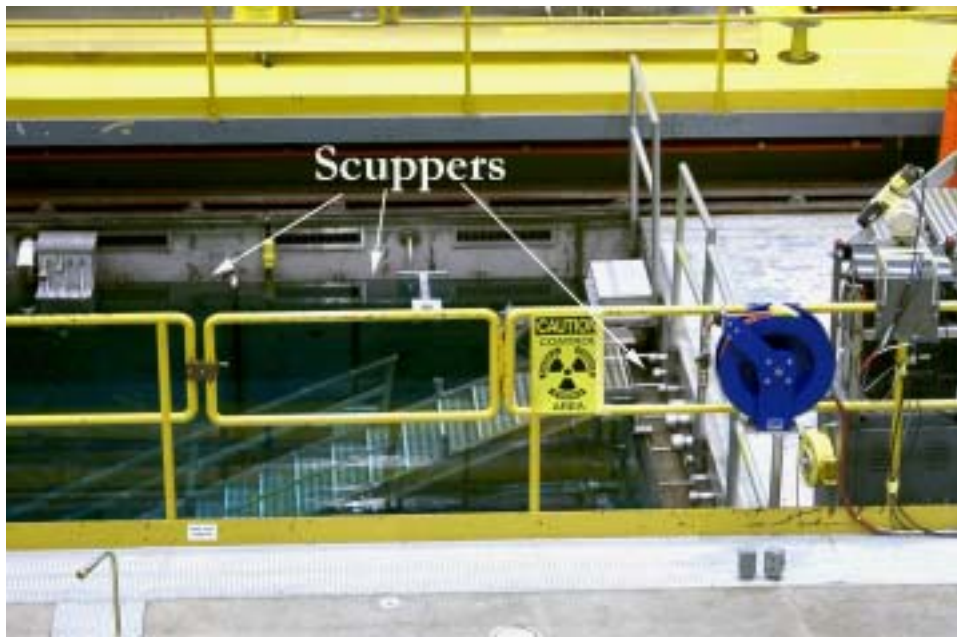
**Figure 1. HFIR reactor pool**

On October 17, 2001, at the Oak Ridge National Laboratory (ORNL) High Flux Isotope Reactor (HFIR), an operator failed to stop the pump filling the reactor pool as required by procedure. As a result, a large volume of pool water overflowed into the scuppers around the pool (see Figure 1). Excess water then filled and overflowed the pool surge tank, filled the collection tanks of the process liquid system, and backed-up through sink drains into the Neutron Activation Analysis Laboratory. Approximately 700 gallons of reactor pool water flowed onto the laboratory floor. Most of this water went down the laboratory drains but approximately 200 gallons went through some pipe penetrations and into the beam room, one floor below. Later measurements showed most contamination levels to be between 300 and 600 dpm/100 cm<sup>2</sup> beta-gamma; however, one isolated particle registered measured 6000 dpm. (ORPS Report ORO--ORNL-X10HFIR-2001-0026)

Investigators of this event concluded that its direct cause was the operator's failure to physically observe the pool water level. However, they also concluded that weaknesses in the procedure and deficiencies in the system design contributed to the event. Although a previous Unreviewed Safety Question raised

As the result of this occurrence, overflow from the pool surge tank has been routed to the tritium process system, which has sufficient volume to accommodate any future pool overflows. Other corrective actions to be taken are:

- Revise the operation procedure to include specific information and direction for monitoring pool level, estimating and monitoring time to complete the water transfer, and monitoring pool surge tank level during pool water transfers
- Install a high-level alarm in the pool surge tank
- Develop operating procedures for lowering and maintaining the pool surge tank level
- Train the operator
